HVDC Tower failure

9th January 2004

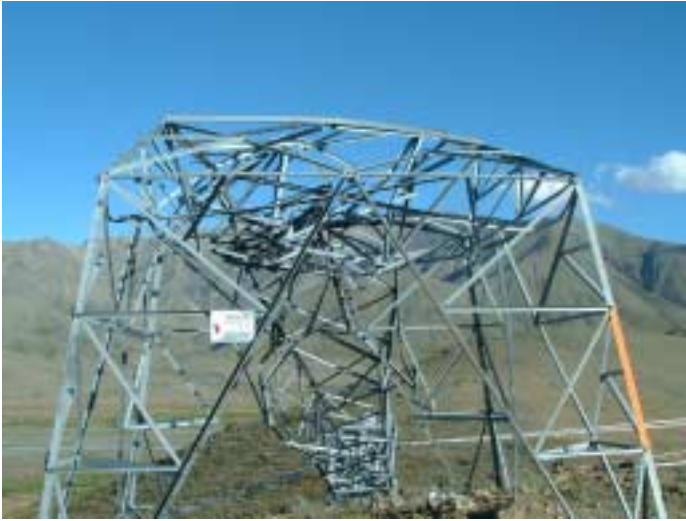
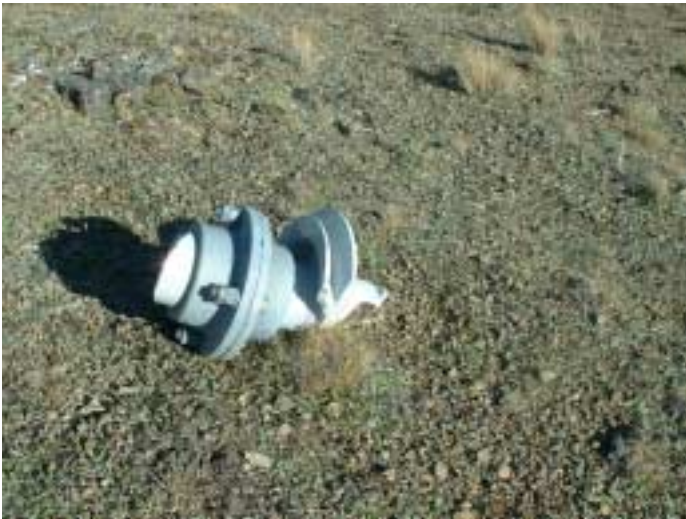
- Heavy Suspension Tower on top of Isolation Saddle
- Modified to Akimbo arm during 1991 upgrade
- Strengthened to NZS4203 during 1991 upgrade

- Windward Akimbo at 1131 appears to have broken under compression loading
- Tower 1131 is thought to have failed first
- Release of conductor at 1132 induced torsion on tower –failed due to wind load
- Tower 1133 (light suspension) failed under direct wind loading
- Armless angles at Towers 1130 & 1134 held
- All towers failed with classical tension / compression buckling

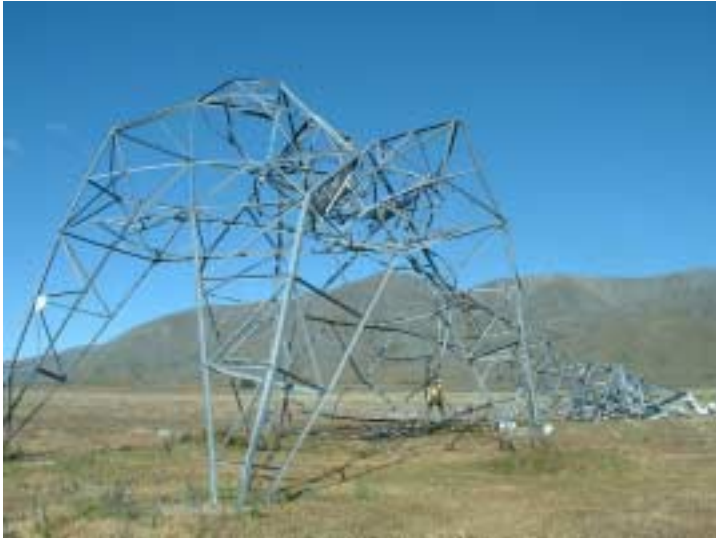
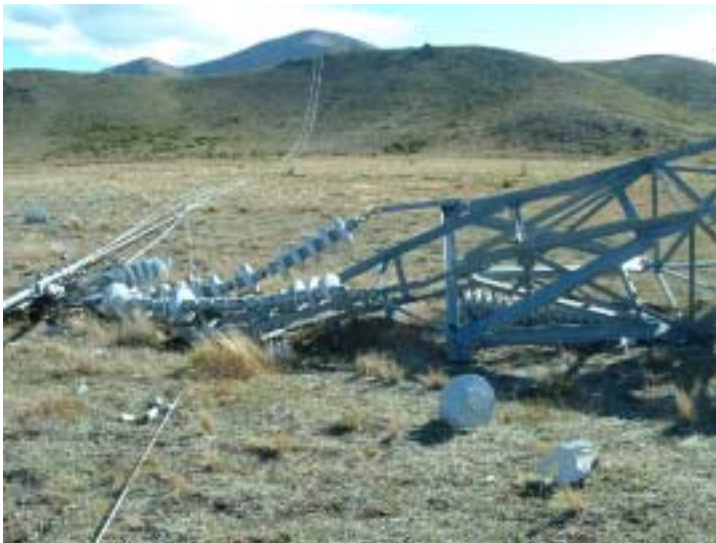
Tower 1132

- Heavy Suspension Tower located on Isolation Flat (valley floor)
- Modified to Akimbo arm during 1991 upgrade

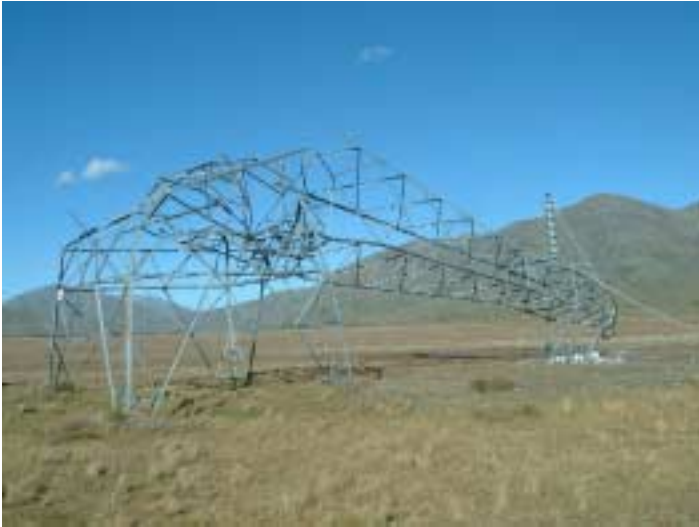
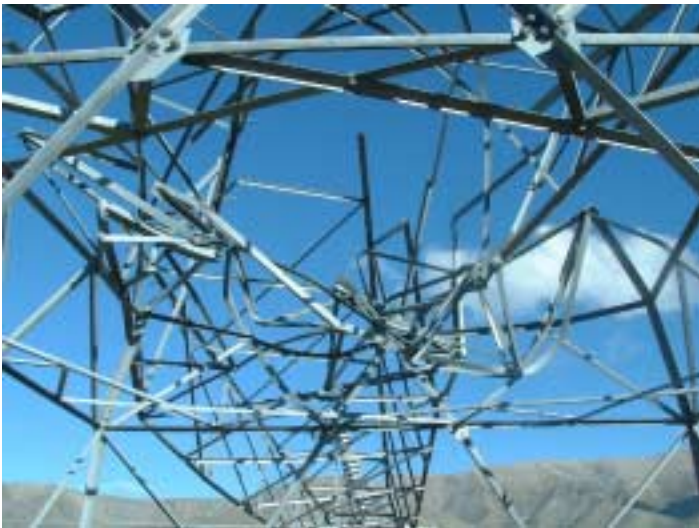
Tower 1133

- Light Suspension Tower located on Isolation Flat (valley floor)
- Normal suspension insulators
- Strengthened in 1964 before commissioning

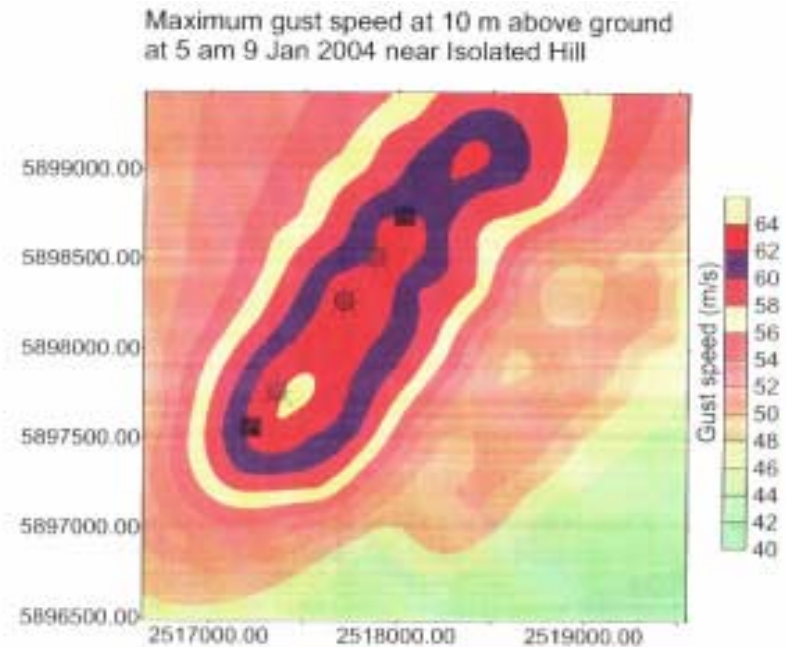
Investigation- Weather data

- NIWA modelling suggests 64m/s, (230 km/h), at ground level, tower 1131
- Conductors experienced 71m/s, (255 km/h)
- Wind event = return period of 1300 yrs

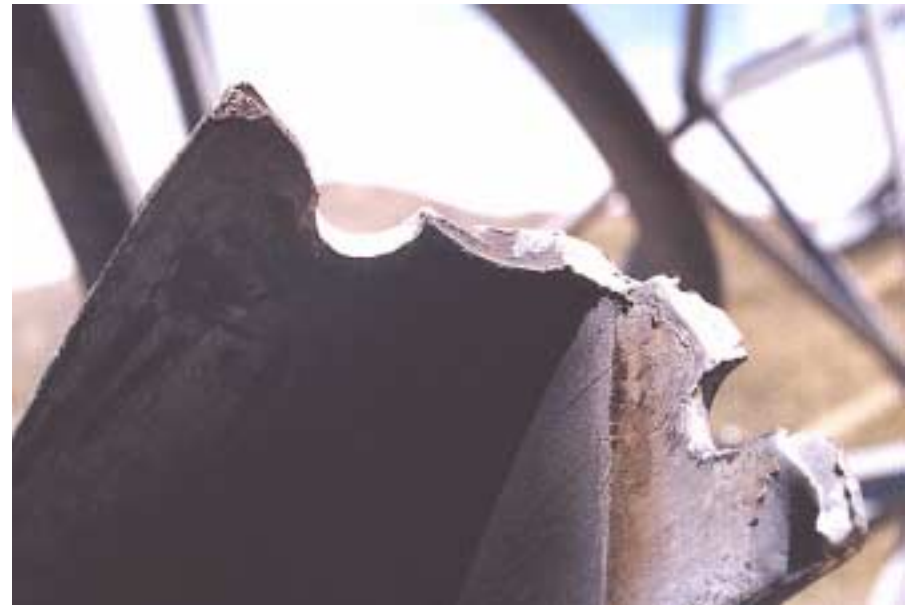
Investigation - Metallurgical Tests

- Metallurgical testing done by SGS (Auckland)
- Samples show nothing untoward
- Failures are all ductile caused by overloading
- No steel fatigue is evident
- Steel was above specified tensile strength
