HVDC Tower failure

9th January 2004

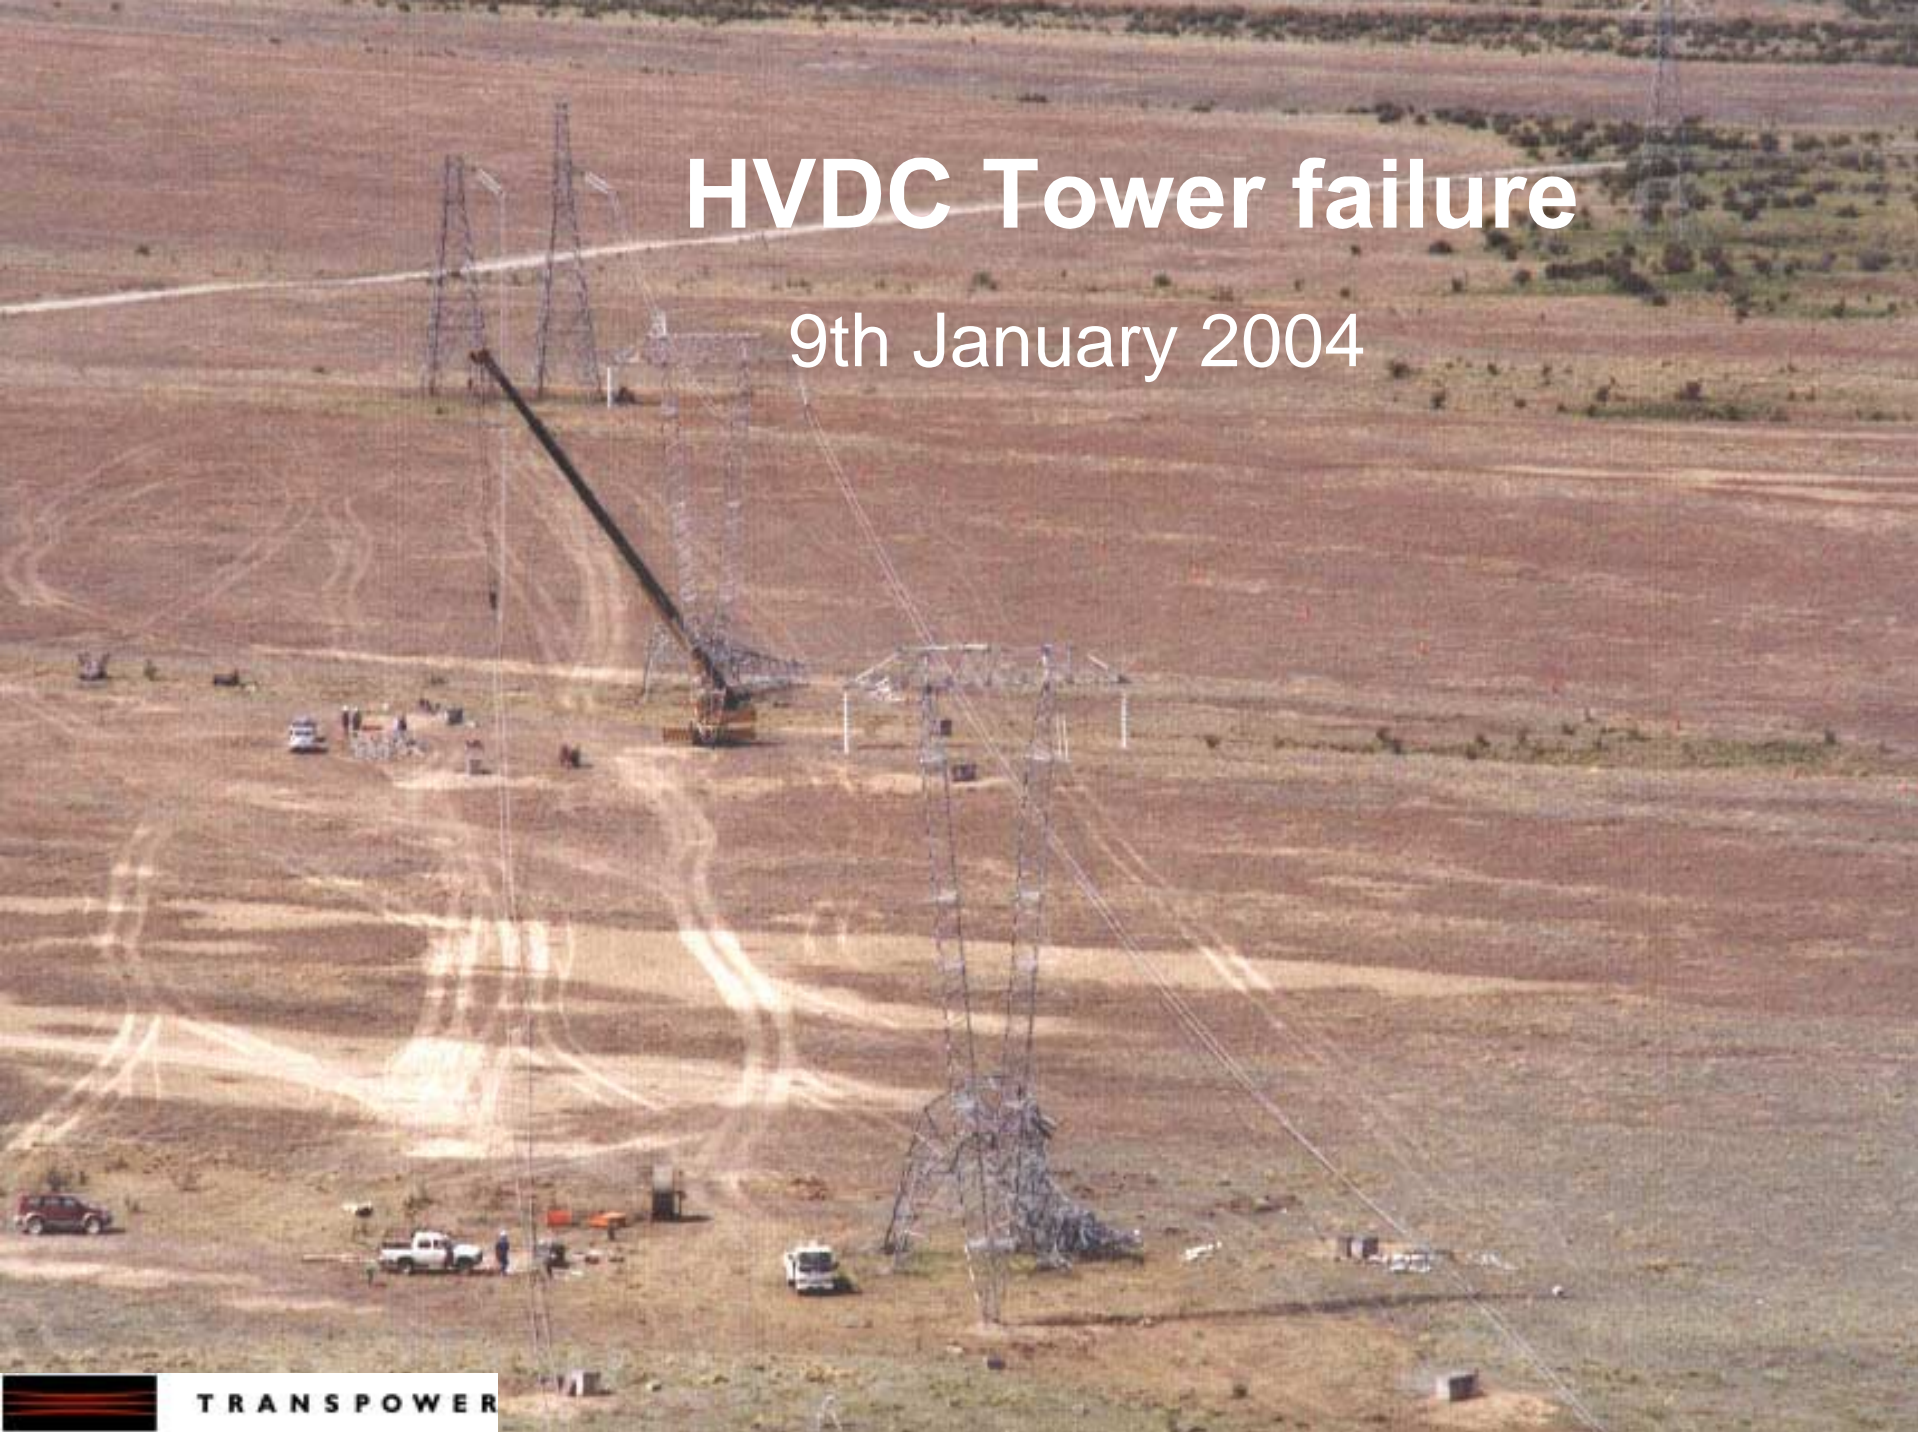
- The HVDC line tripped at 4.02am on 9th January. Only Pole 2 was in service, with minimal transfer south to north
- Not known if the towers failed at this time - wind blown debris at a variety of sites could have caused the initial tripping
- Molesworth Station manager advised Transpower of damaged towers at 7:41am - “crumpled Meccano”
- Contractors reached site mid-morning and confirmed 3 towers had failed - 1131, 1132 and 1133
